UNDERWATER FACILITIES INSPECTIONS AND ASSESSMENTS AT
NAVAL TRAINING CENTE. (U) BLAYLOCK-HILLIS AND
ASSOCIATES SAN DIEGO CA OCT 84

UNDERWATER FACILITIES INSPECTIONS & ASSESSMENTS

FPO-1-84(21)

OCTOBER 1984

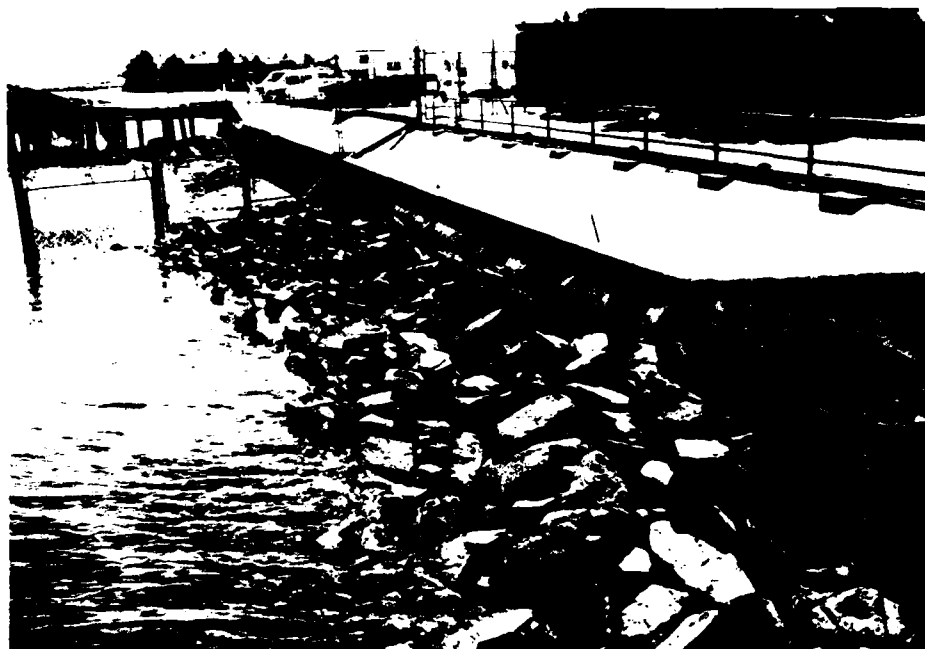
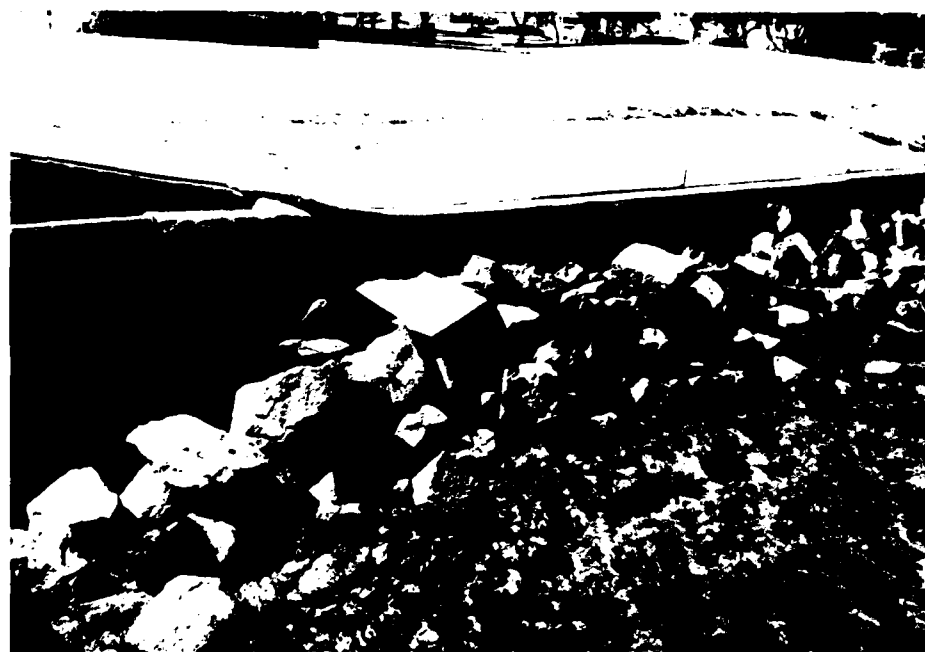
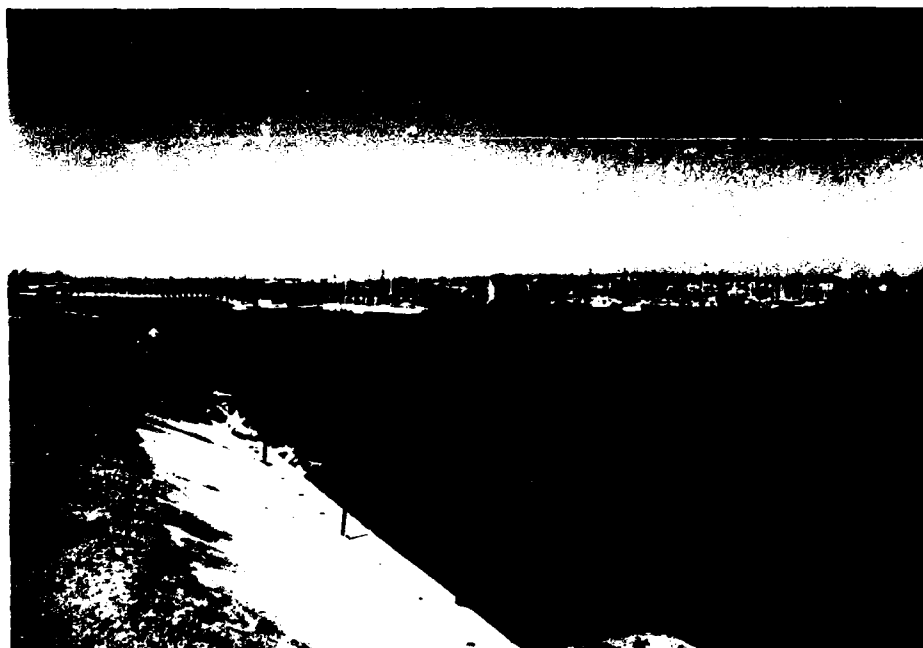
The concrete Bulkhead at the South Boundary exhibits no symptoms of deterioration or distress. It has two vertical cracks - 69 feet and 124 feet north of the boundary fence. The cracks occur at changes in the wall cross section and small voids appear to be forming behind the wall at these locations.

As described above, there are no symptoms of distress at the South Boundary Bulkhead. The vertical cracks in the wall appear to be construction joints and represent no threat to the walls integrity. The small voids forming behind the crack can be filled with a lightly cemented soil very easily by station personnel.

11. South Boundary Bulkhead. Picture is taken from the base of Pier 9. View is to the south. Fence in the background represents the south boundary of NTC.

12. South Boundary Bulkhead. Picture is taken from the base of Pier 9. View is to the northwest.

13. South Boundary Bulkhead from base of Pier 9. View is to the northeast. Harbor Island is in right background.

1. The two small voids behind the South Boundary Bulkhead at Stations 0+69 and 1+24 be filled with a soil-cement material to prevent further erosion at these locations and the wall inspected again in six years. Estimated cost of repair is \$1,000.

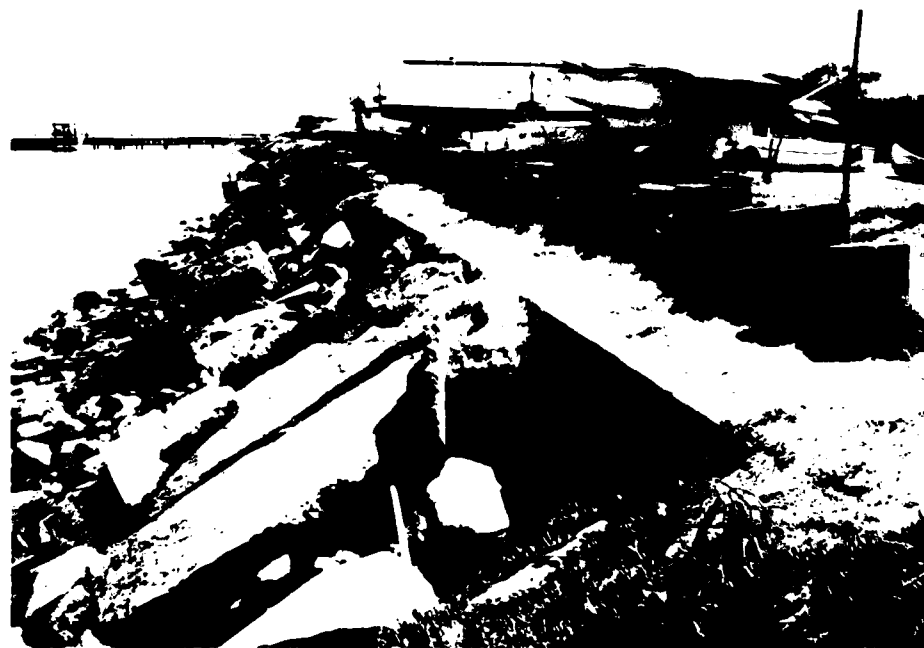
The concrete Bulkhead at Pier 548 shows no symptoms of deterioration but is, however, undermined for approximately 18

The Pier 548 structure appears to be a reinforced cantilever section with a footing behind the wall beneath the backfill. However, from measurements taken at the undermined area, the depth (the distance measured perpendicular to the wall) of the footing appears to be inadequate. This could account for the bulge and slope now exhibited by the stem.

14. Pier 548 Bulkhead. View is from the base of the Pier to the south.

2. The 18 foot undercut of the Pier 548 Bulkhead be filled with lean concrete placed through excavated holes from the landside, and the wall inspected again in six years. Estimated cost of repair is \$1,000.

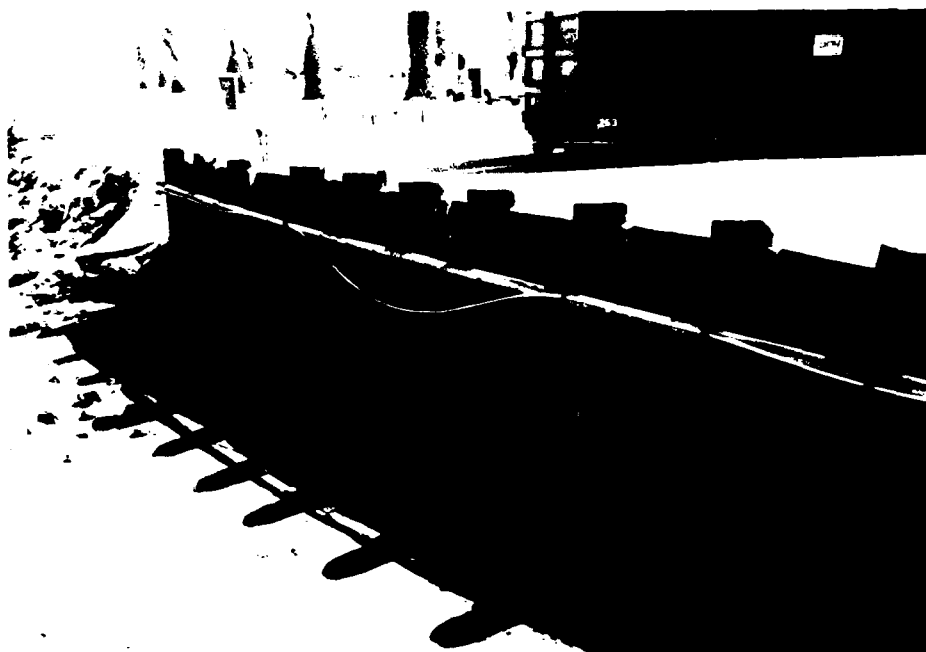
At Pier 446, the Bulkhead exhibits a classic case of dry rot decay. The bottom of the wall, at the mudline, is below water at high tide. The piles have surface symptoms of dry rot although no pile is completely decayed through. However, the 2 x 12 lagging is completely decomposed in several places exposing rip-rap backfill. There is no evidence of surface subsidence behind the wall.

At Pier 446, the wall is obviously badly damaged and clearly its ability to sustain loads is reduced. It was noted that the area behind the wall is paved and used for parking of vehicles and equipment. Although there is no present indication of surface subsidence or wall movement, there is a possibility of wall failure under heavy surcharge.

15. Pier 446 Bulkhead. View is from Pier 446 southward showing the south wing of the Bulkhead. Deteriorated lagging is clearly shown.

3. The Bulkhead at Pier 446 be replaced within two years or the vehicle parking behind the wall restricted. The estimated cost of replacement is the sum of \$79,600 (See Section 5 for a detailed cost estimate). It is also recommended that the new wall be inspected after its completion.

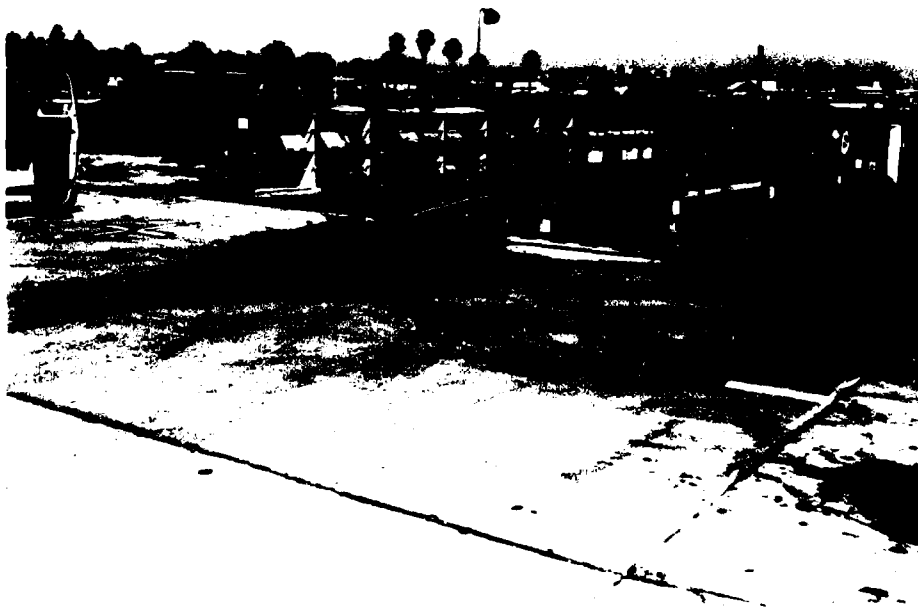
18. Pier 445. View is of surface depression above deteriorated Bulkhead.

4. The Pier 445 Bulkhead be replaced as soon as possible and the vehicle parking adjacent to the wall restricted. The cost of replacement is estimated as \$33,800 (See Section 5 for a detailed cost estimate). It is recommended that the new wall be inspected when completed.

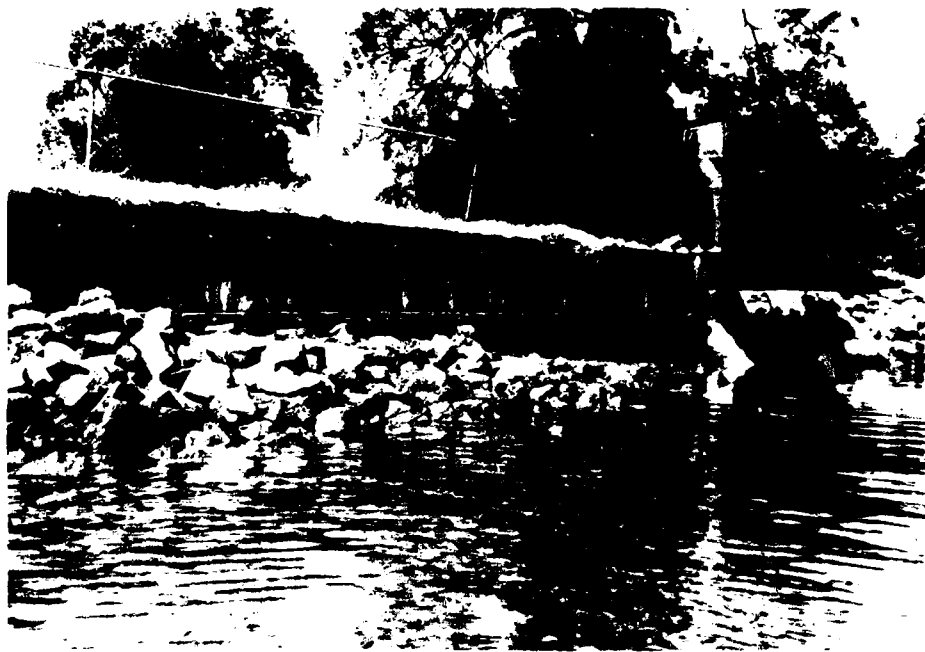
At the North Boundary, the wall exhibits similar deterioration to the Bulkhead at Pier 445. The bottom of the wall is in water at high tide and has suffered dry rot damage to both lagging and wales. A large void has occurred in the backfill at the north end of the wall.

19. North Boundary Bulkhead. Fence in the right foreground is the boundary with Marine Corps Recruit Depot. The wood has deteriorated from dry rot.

7. North Boundary Bulkhead - The wooden Bulkhead is badly dry rot deteriorated. It is recommended that it be replaced. The estimated cost of replacement is \$62,800.

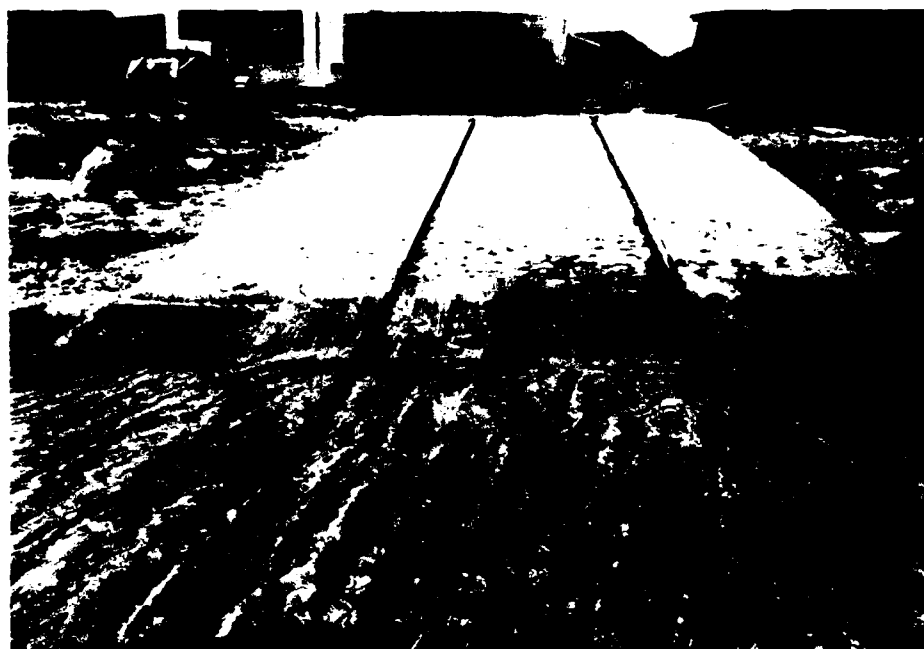
The problem appears to occur at low tide when boats on wheeled cradles are being taken out of the water. There is an abrupt drop at the end of the Ramp which causes cradle wheels to hang up.

21. Boat Ramp 529. Viewed inboard from the water.

It is recommended that a sufficient volume of 1 1/2 inch aggregate be deposited at the end of the Ramp to smooth out the drop and fill the void. It is estimated that the cost would be \$2,500.
